RE: Site Inspection, Jumbo Mining Company, Drum Mine, M/027/007,
Millard County, Utah

Date of Inspection: April 14, 1993
Time of Inspection: 1130 - 1530
Conditions: Cool, clear, light breeze
Participants: Dave Hartshorn, JMC; Rody Cox, BLM; Lowell Braxton,
Tom Mitchell & Wayne Hedberg, DOGM

Purpose of Inspection: Evaluation of current operational state and site
familiarization for DOGM management and legal counsel.

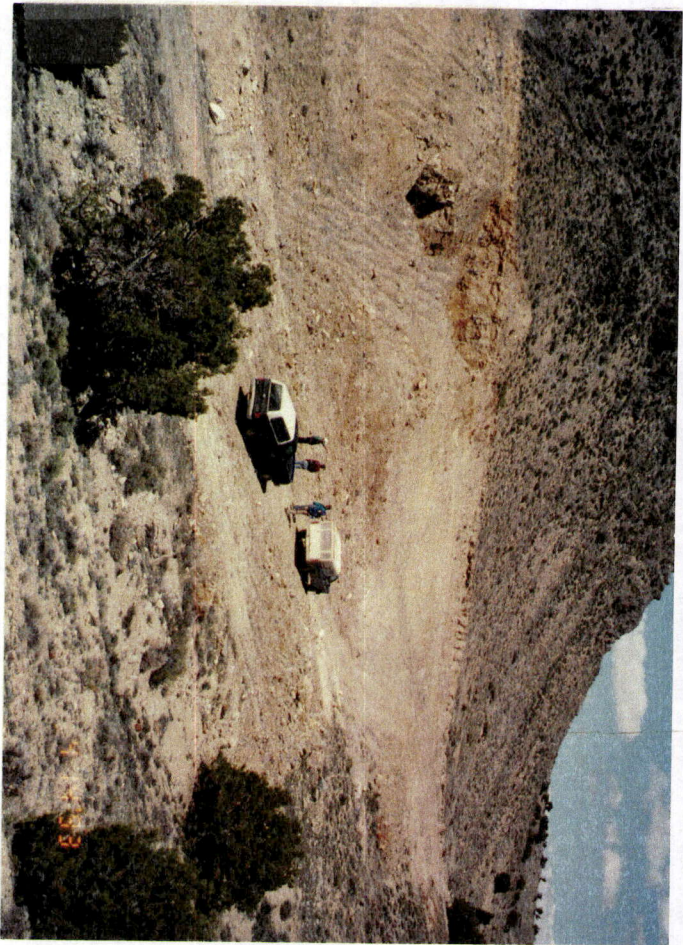
another view of area that could
serve as a topsoil "borrow source"

* Note old gravel "digger trenches/mounds"
in foreground

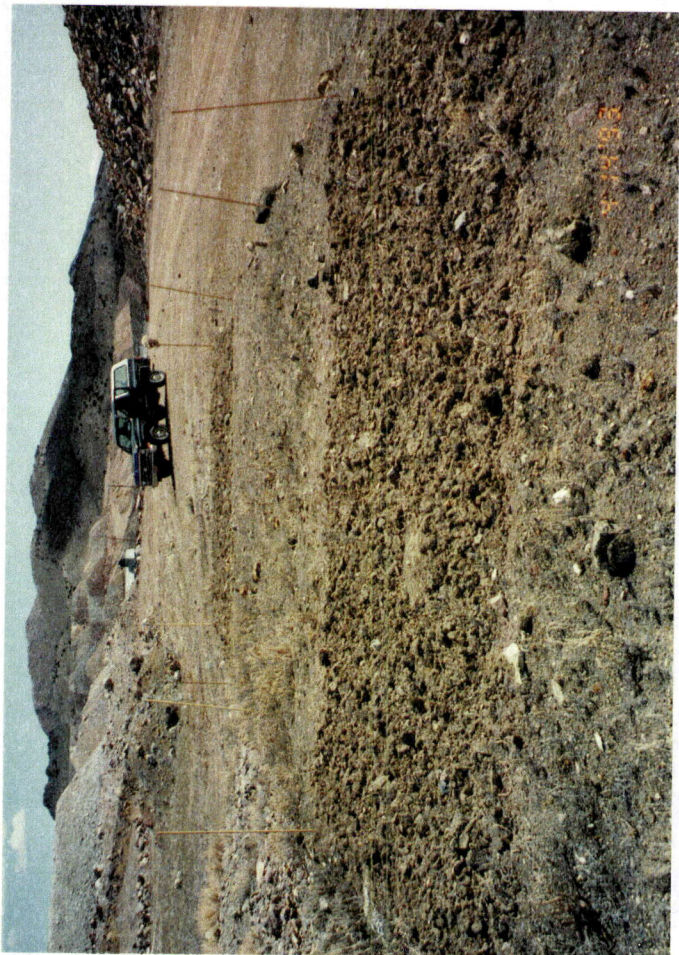
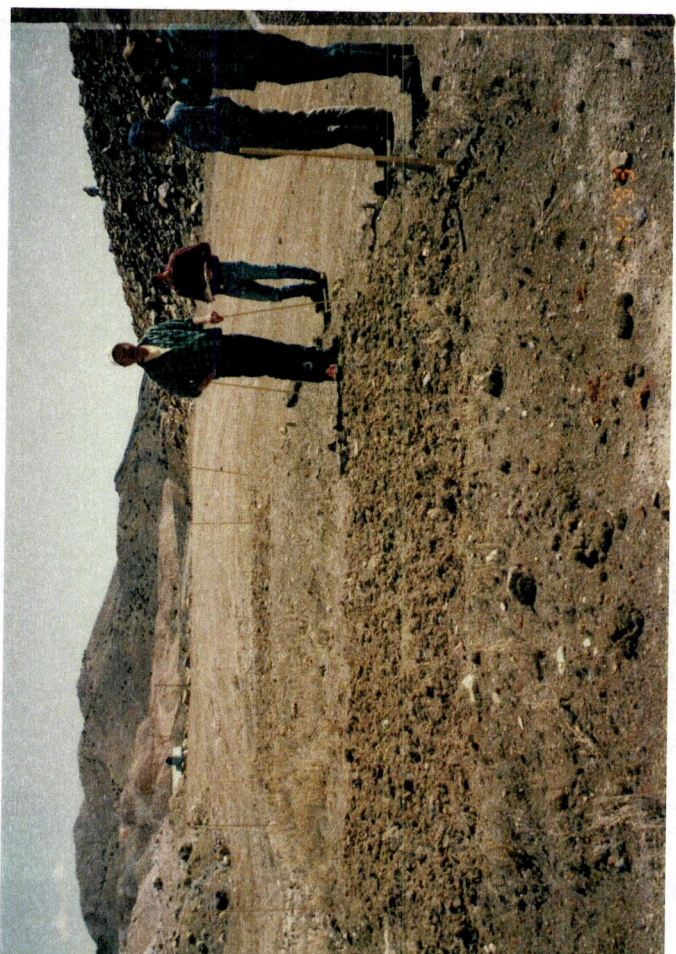
TEST PLOTS

Mr. Hartshorn indicated that the second test plot has more recently (within last 2 weeks?) been reworked and reseeded. He has split this plot into 3 separate sections; all have @6 inches topsoil, two sections have been ripped/scarified, 2 sections have also been fertilized, and all were reseeded (broadcast at @20 lbs/acre - seedmix as above). Mr. Hartshorn indicated he has been watering this test plot every 2-3 days. No evidence of seed germination was observed at the time of our inspection.
